Embedded Gage Impact Study

**S.W. SCHRAMM and
I.M. DANIEL**

IIT Research Institute
Chicago, IL 60616

NASA Contract NAS1-16763
January 1984

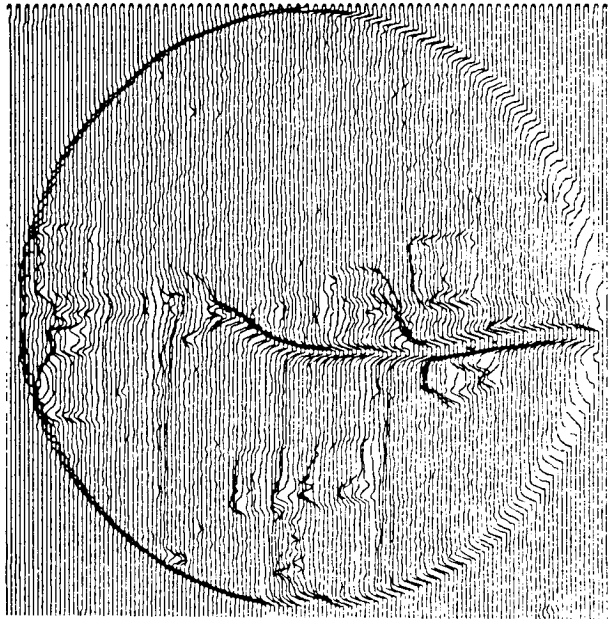
Figure 21. Analog ultrasonic C-scans for $[45/0/-45/90]_{2s}$ laminate before and after impact of a 185 gm impactor from 165 cm height. (Specimen B5-1)
